Program Objectives

Training – Education – Apprenticeship Testing - Certification

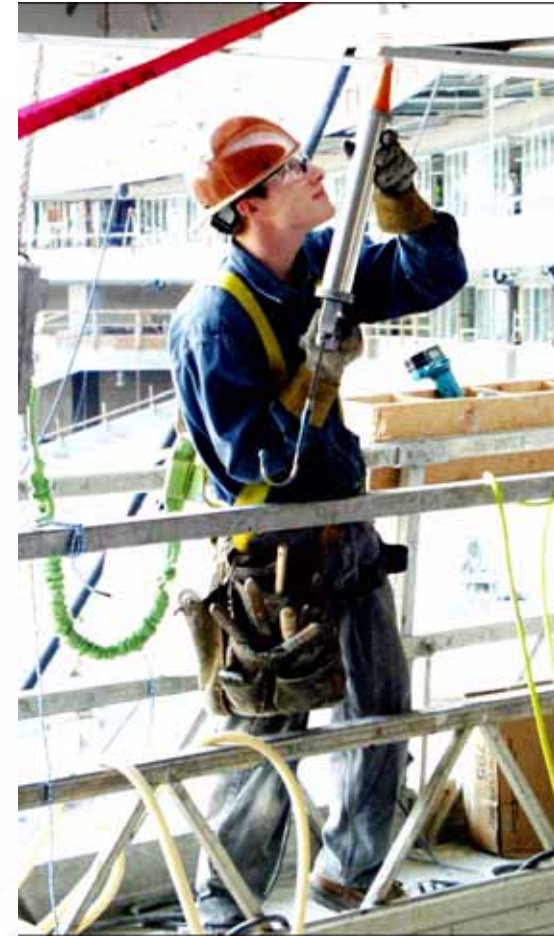
Adhesion Failure

Adhesive Failure

1. Did the joint exceed the expected movement?
2. Was the right material installed?
3. Was the joint prepared properly (cleaned - primed)?
4. Was the sealant installed properly (depth & profile)?
5. What is the expected lifetime of the sealant?
6. Has the adherend (substrate) maintain its strength or deteriorated due to fatigue?

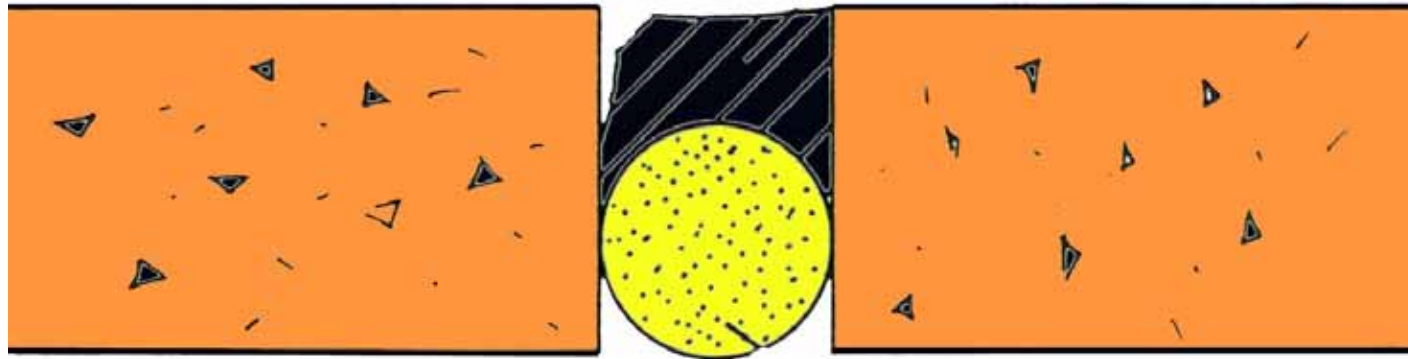
Cohesive Failure

1. Was the sealant of proper depth?
2. Has the joint moved more than the sealant's ability?
3. If a multi-component, was material mix correctly?

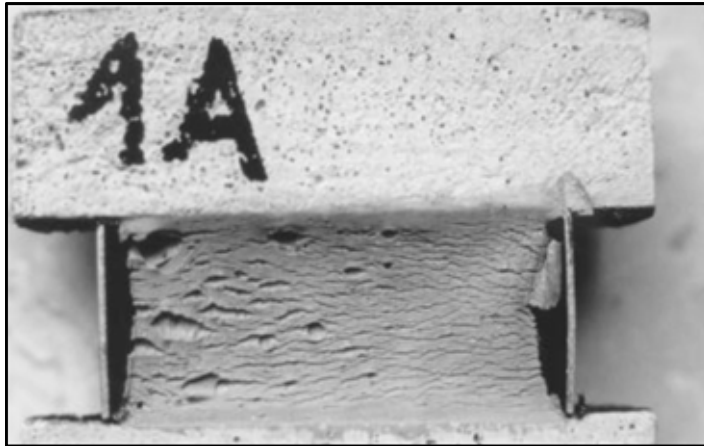
Aging/Weathering (Organic Sealants)

Polyurethane Sealant
Craze Cracking

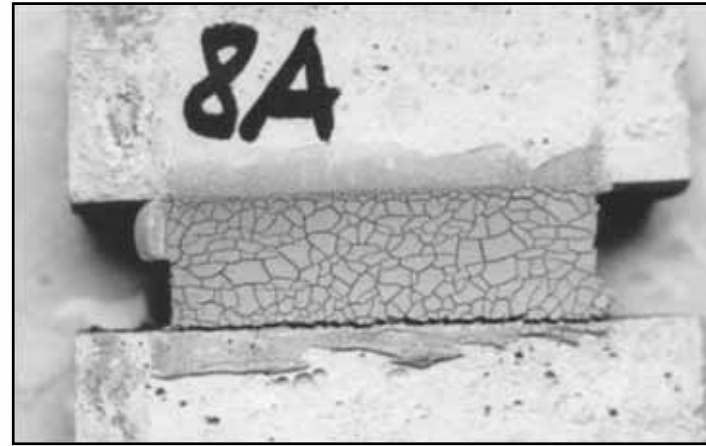
Polysulfide Sealant
Mud Cracking

Edges of the sealant have bleached white

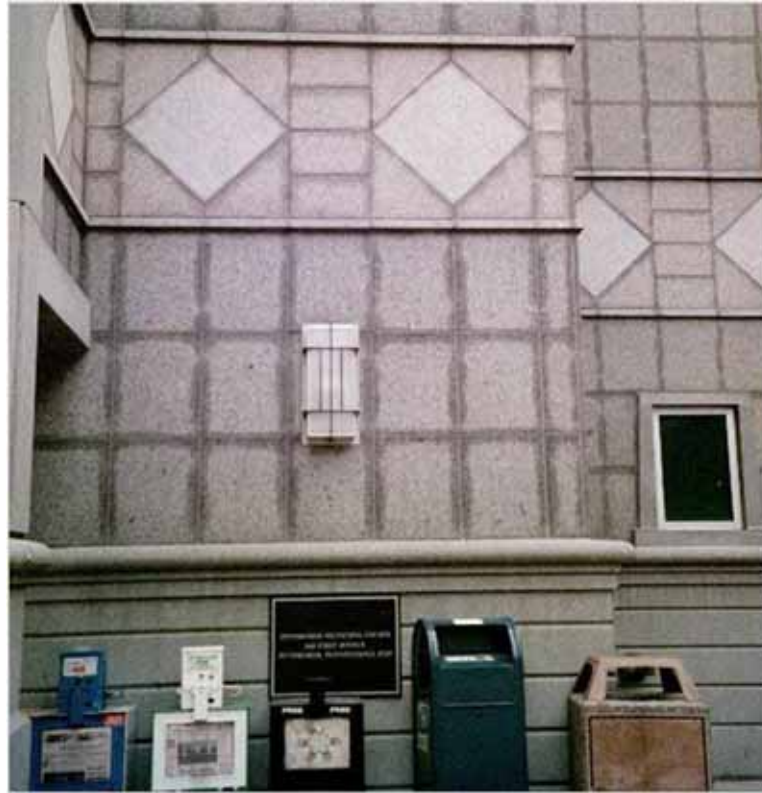
Using ASTM C-1248 Stain Test Method

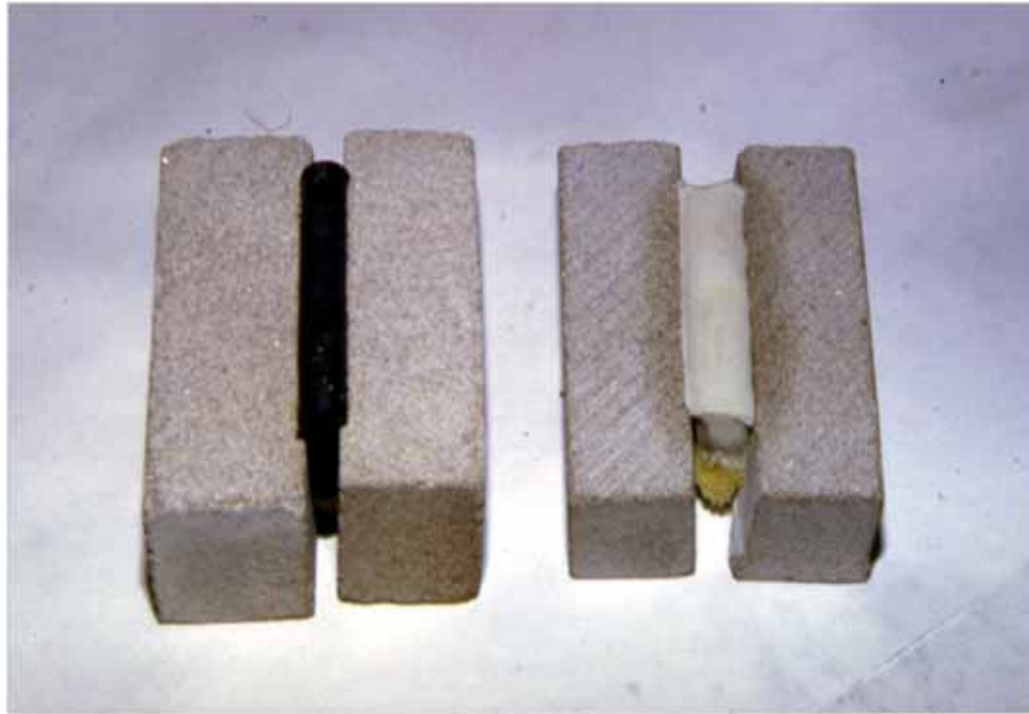
Indiana Limestone

Caused by organic
setting blocks

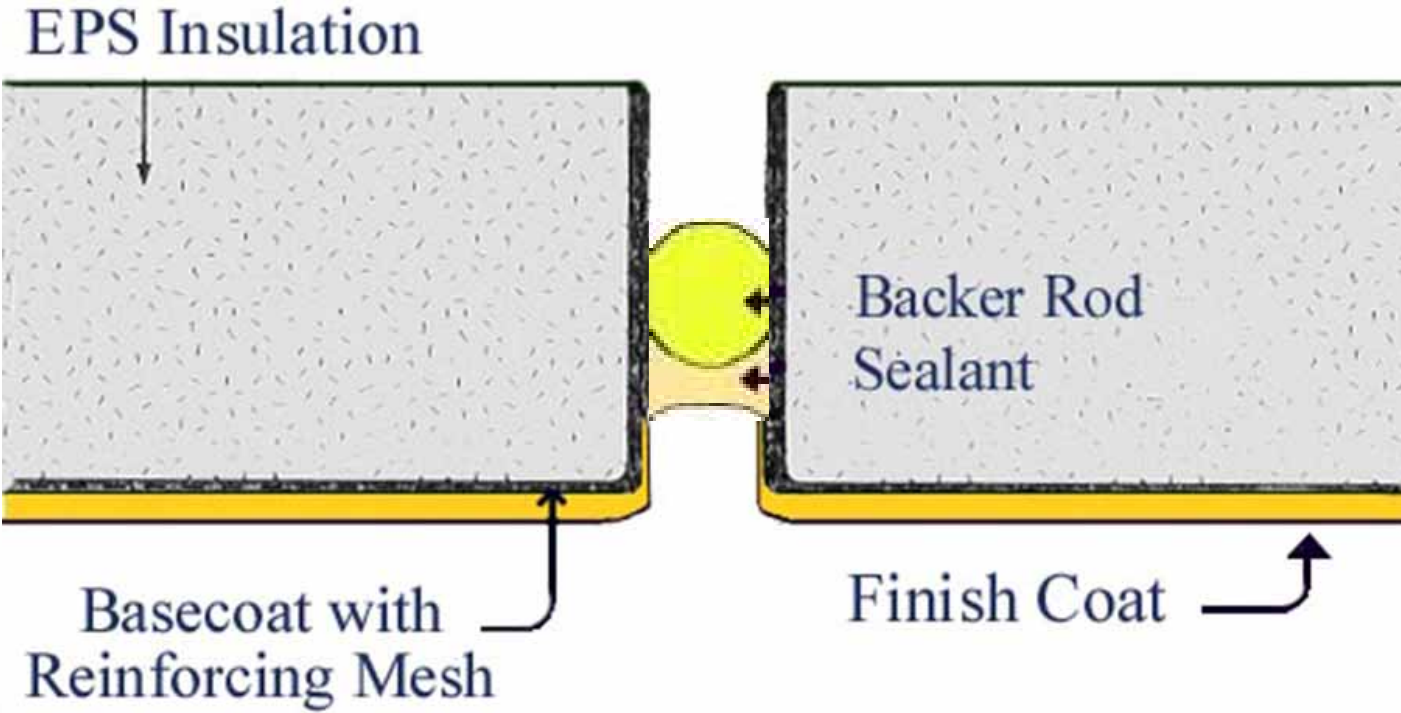
EIFS Joinery (Proper Location of Sealant Bead)

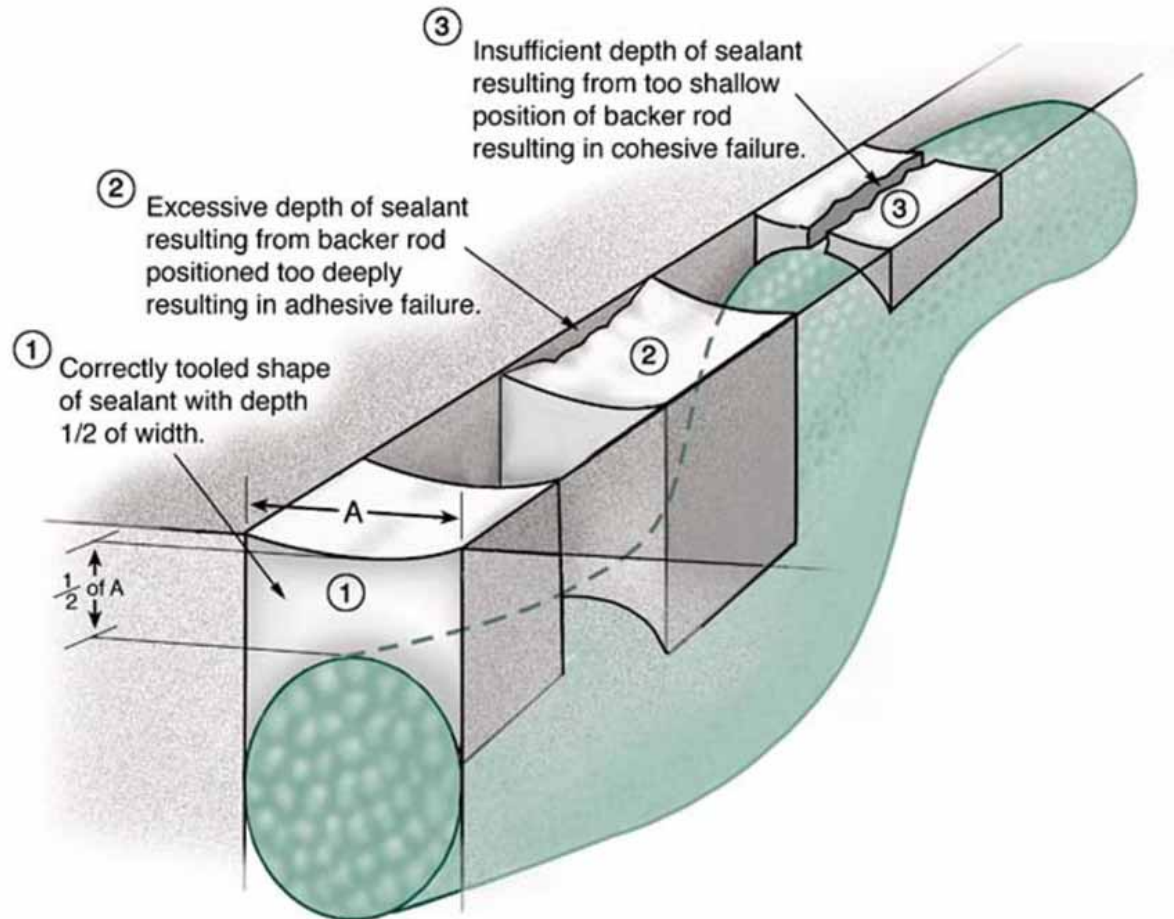
Purpose of Backer Rod

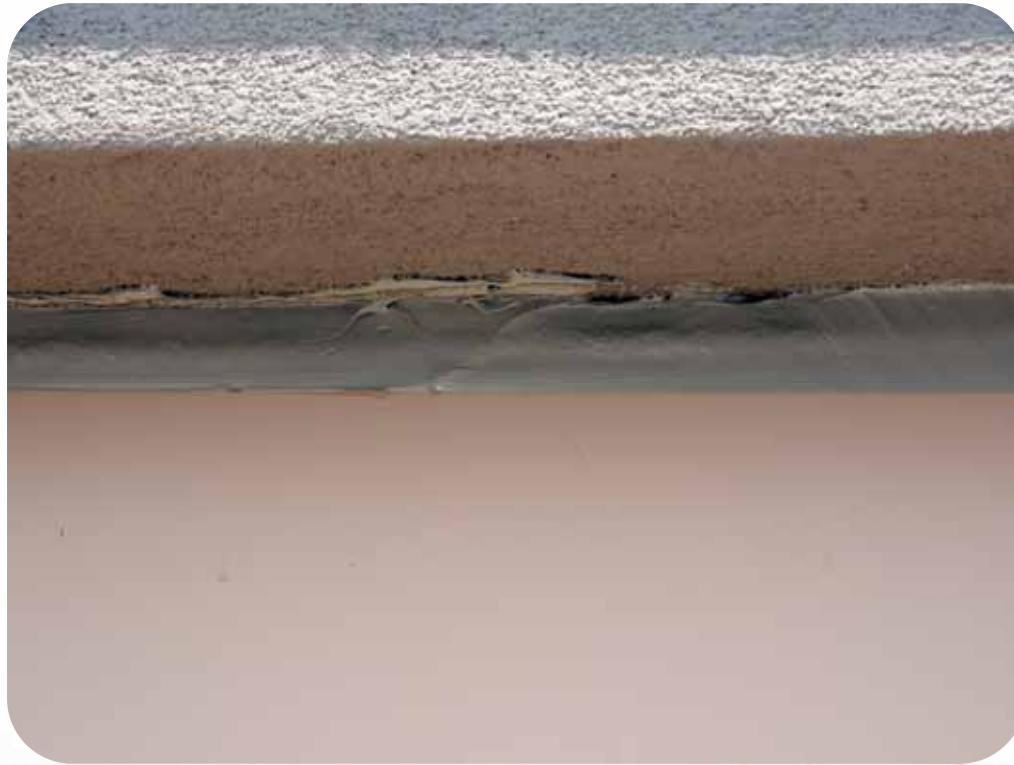
Sealant Performance

***** Applicator Error *****

(Sealant too thin, backer rod is telescoping thru the Sealant Bead)

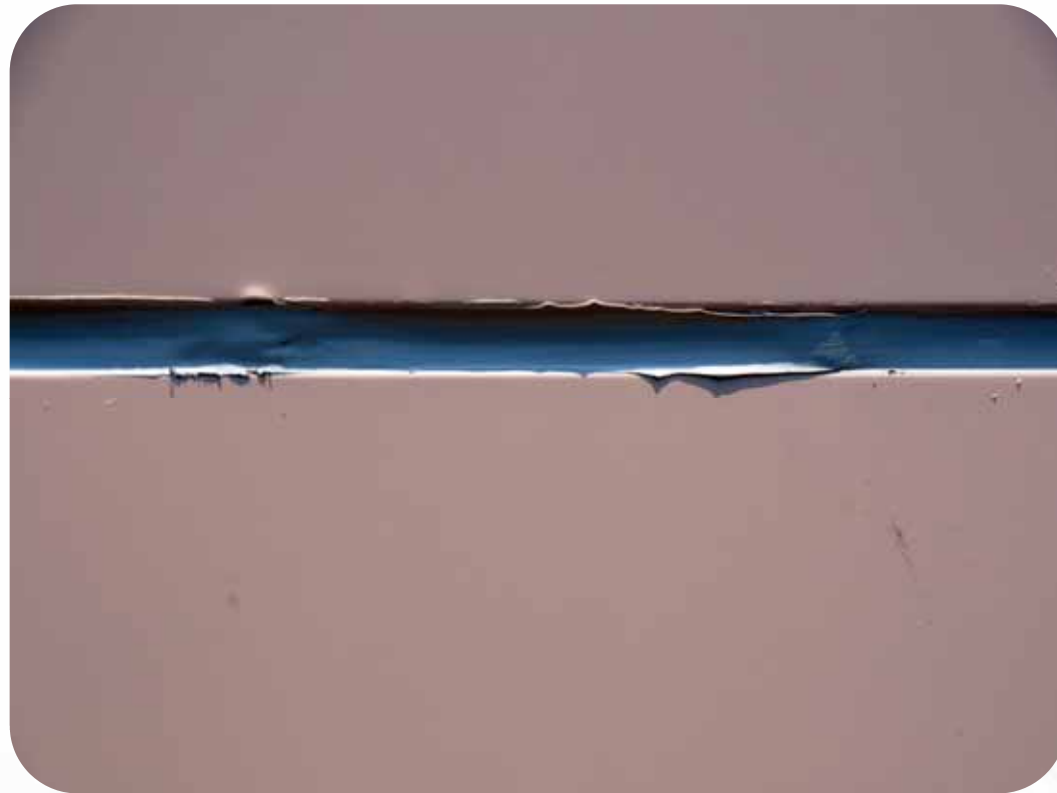
Aesthetic Issues

***** Construction Defects *****
(Masking tape caused this appearance)

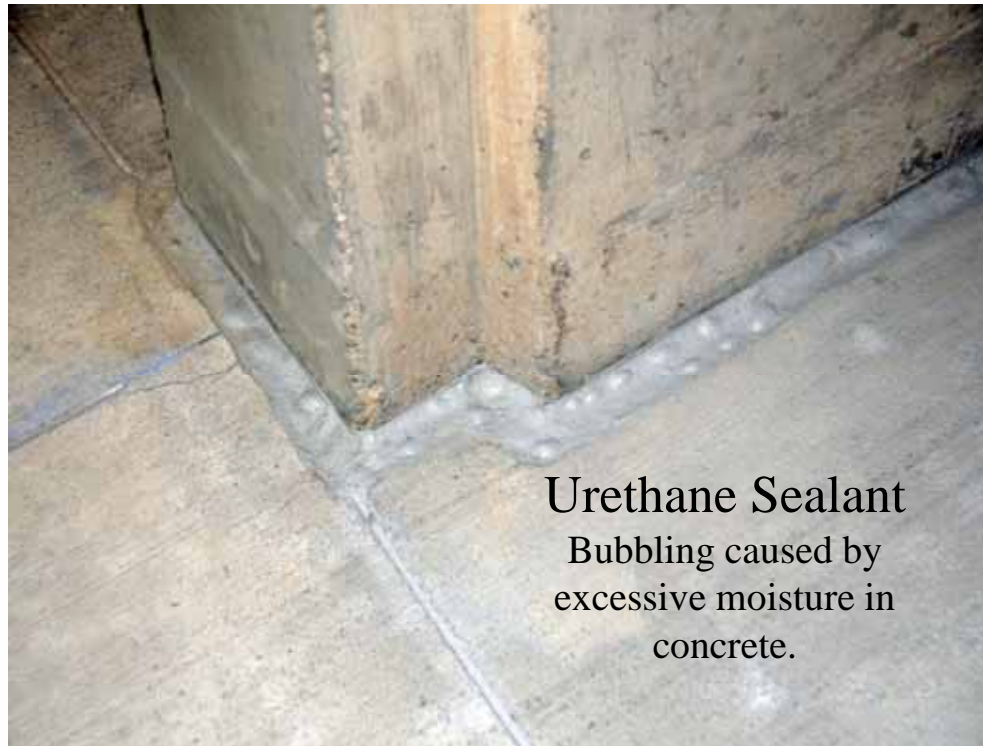
Aesthetic Issues

(Applicator Error for not testing for moisture)

Urethane Sealant
Bubbling caused by
excessive moisture in
concrete.

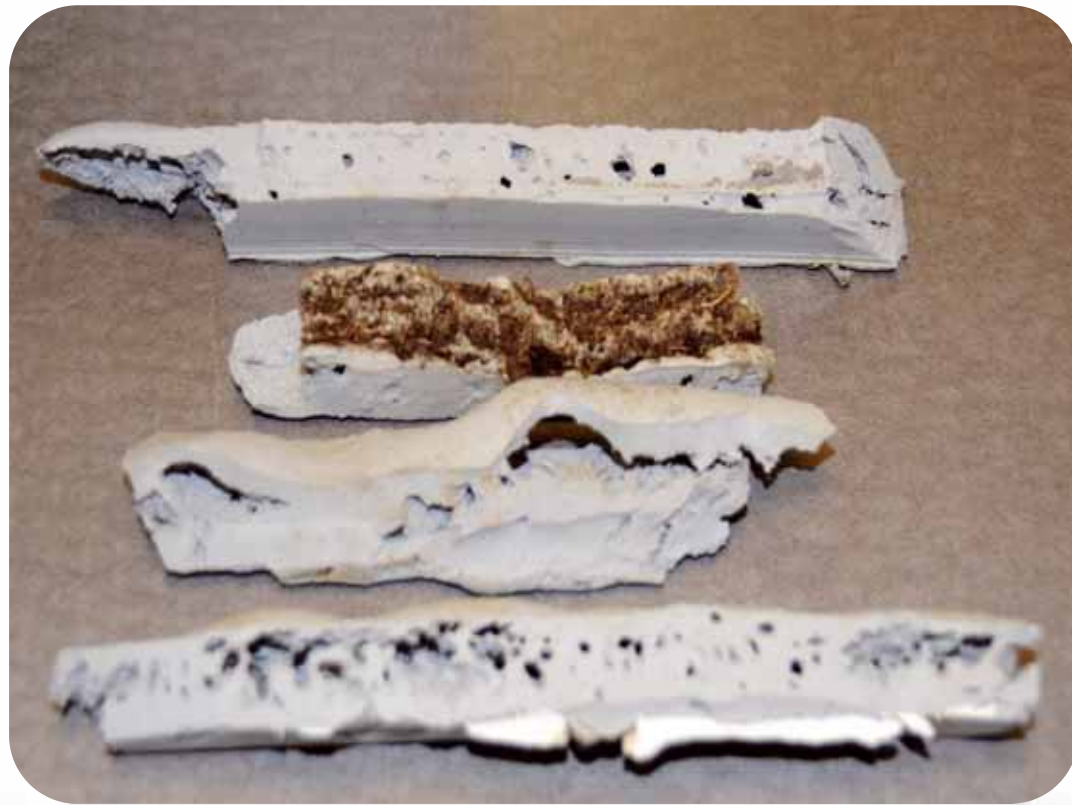
Installation Issues

(Applicator Error)

Protect by installing a Mock Up first

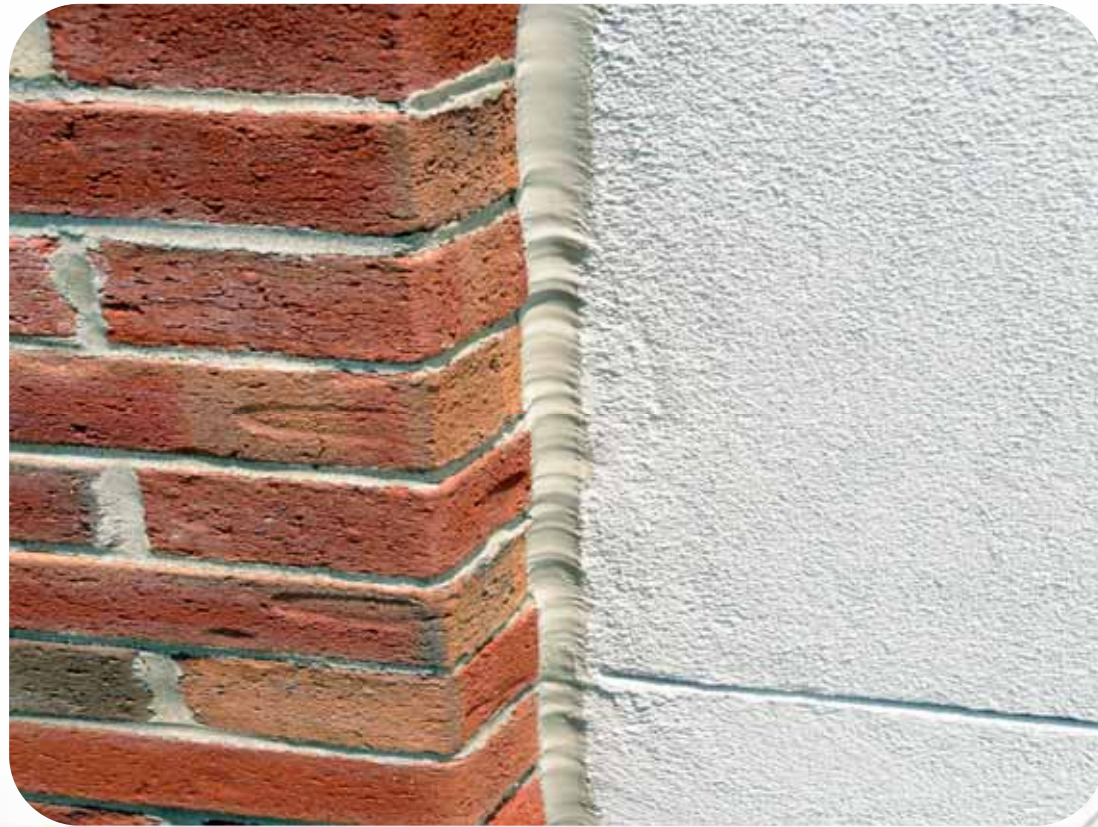
Aesthetic Issues

(Bad tooling practice below)

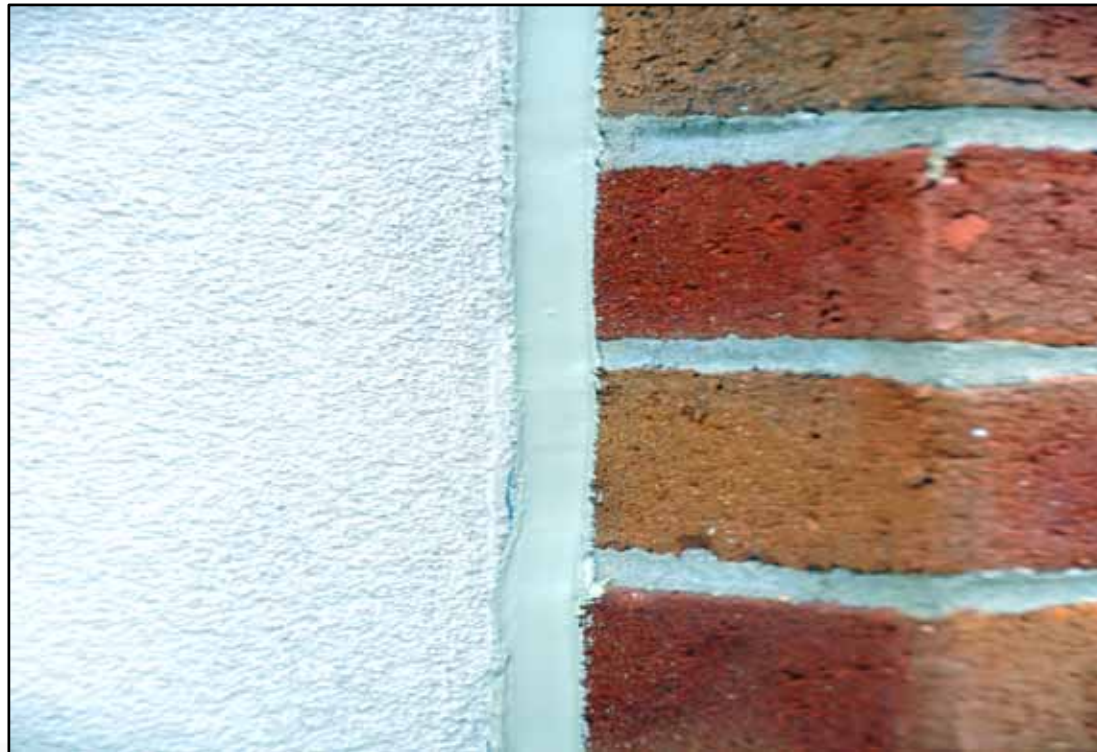
Proper Aesthetic

(Correct Tooling and Appearance)

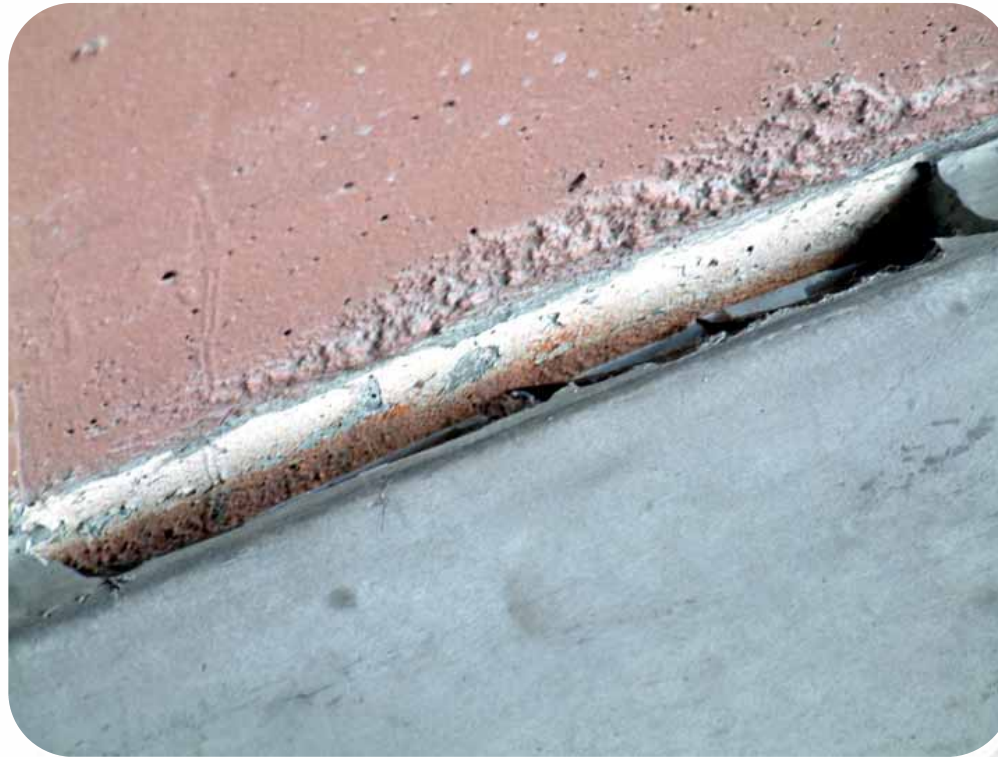
Compatibility Issues

***** Failed Adhesion *****

(Foreign material must be removed from the bond line first)

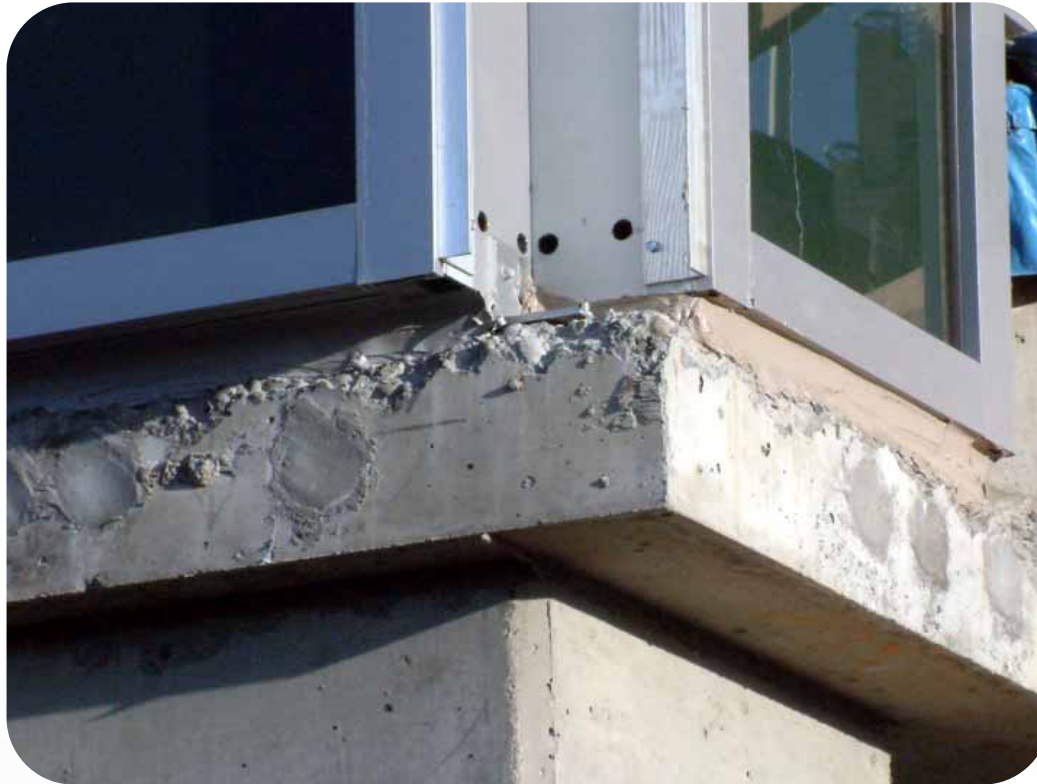
Substrate Conditions Affecting Sealants

*** Tolerances & Adhesion ***

(Bushed concrete is not an acceptable surface for sealant application)

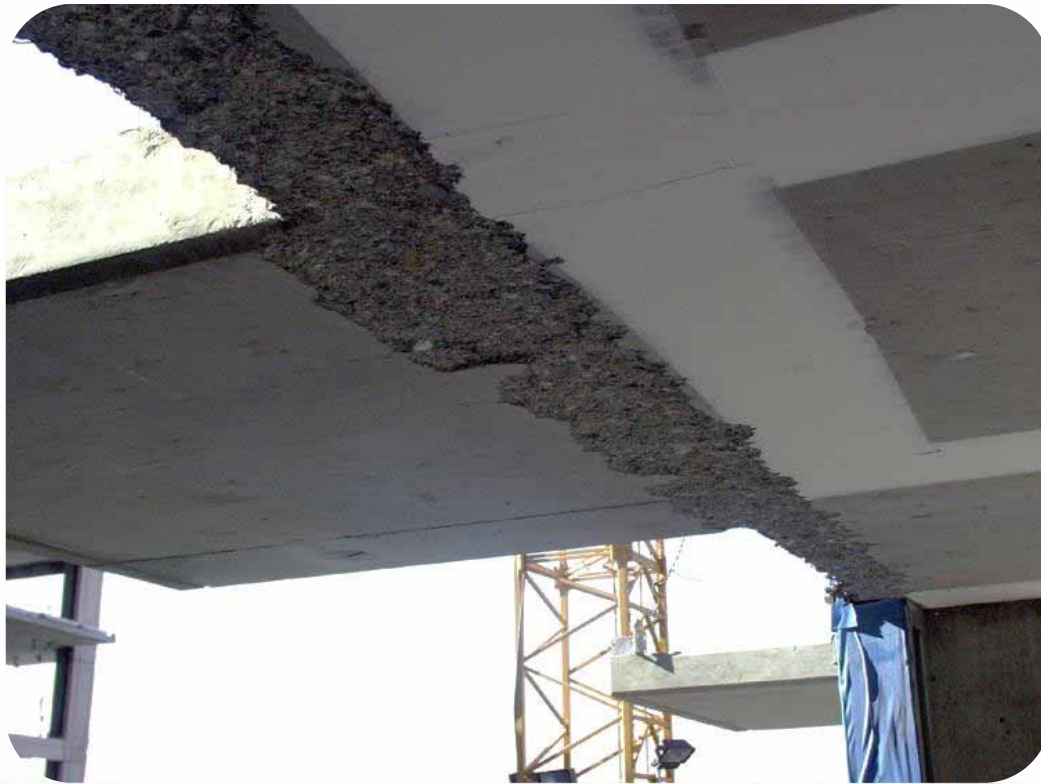
Substrate Conditions Affecting Sealants

*** Tolerances & Adhesion ***

(Bushed concrete is not an acceptable surface for sealant application)

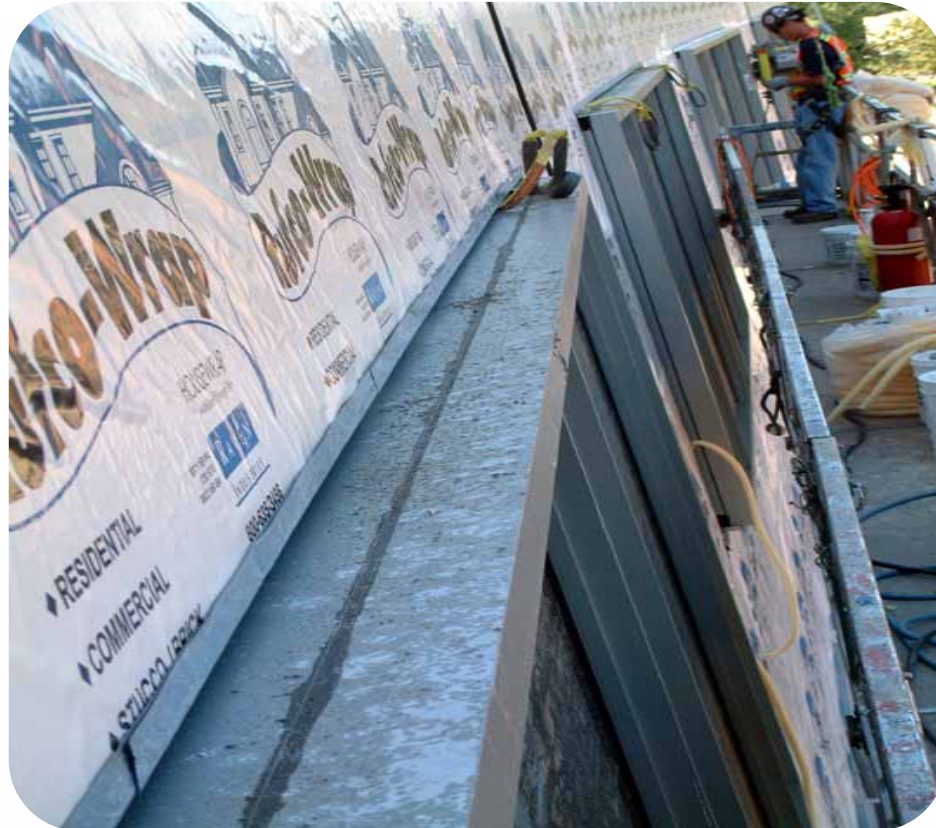
Construction Site

(Dirty/contaminated surfaces can prevent proper sealant adhesion)

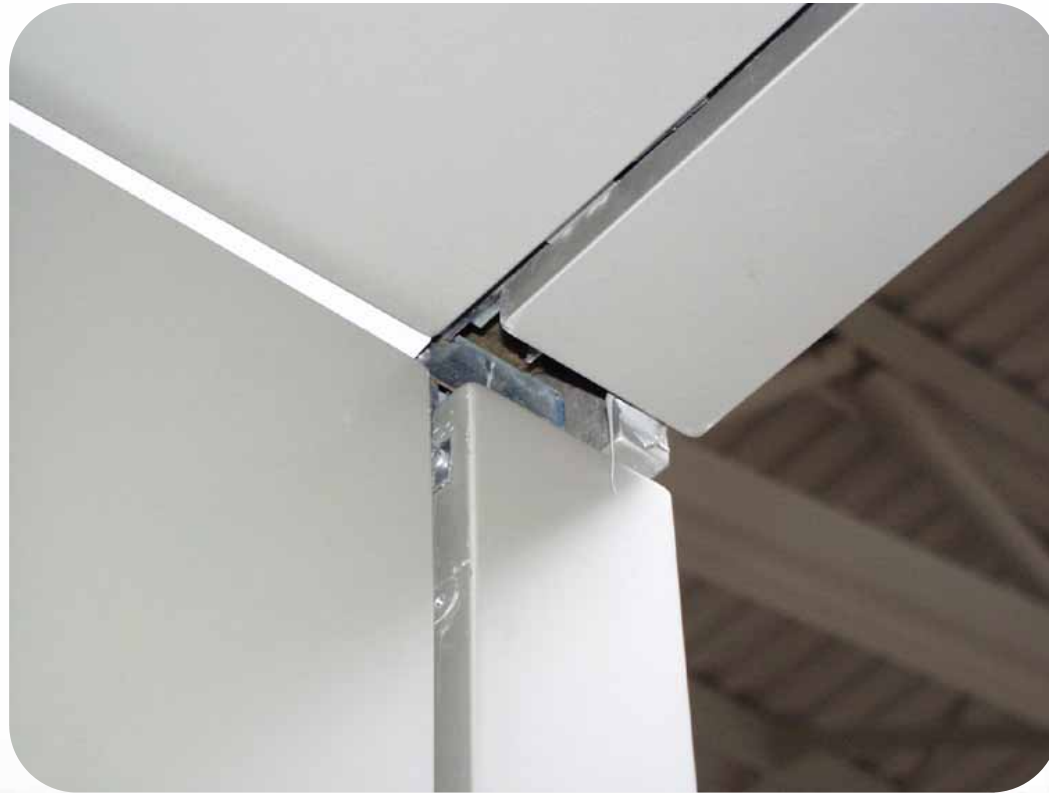
Substrate Conditions Affecting Sealants

***** Panel Alignment *****
(Construction Defect)

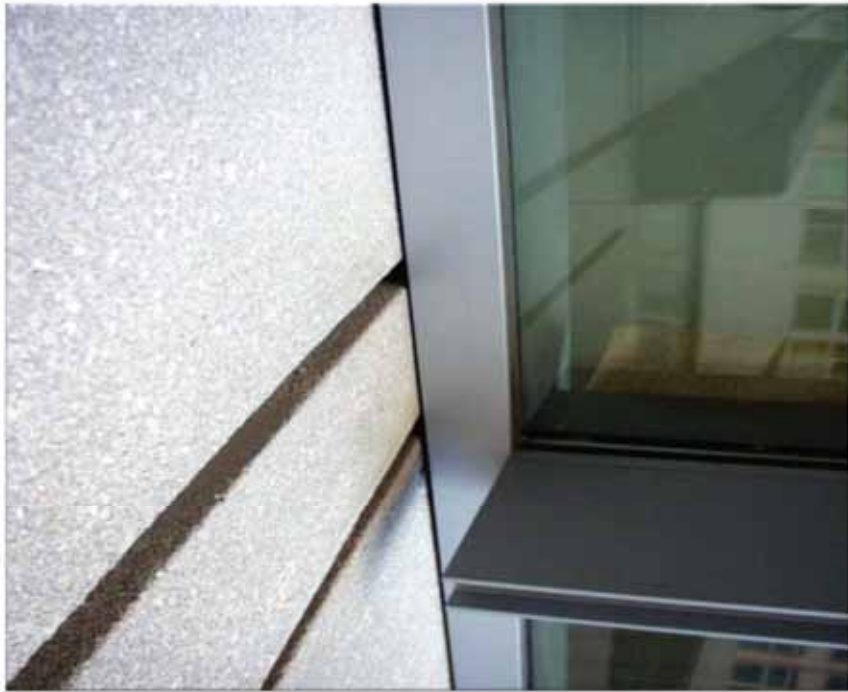
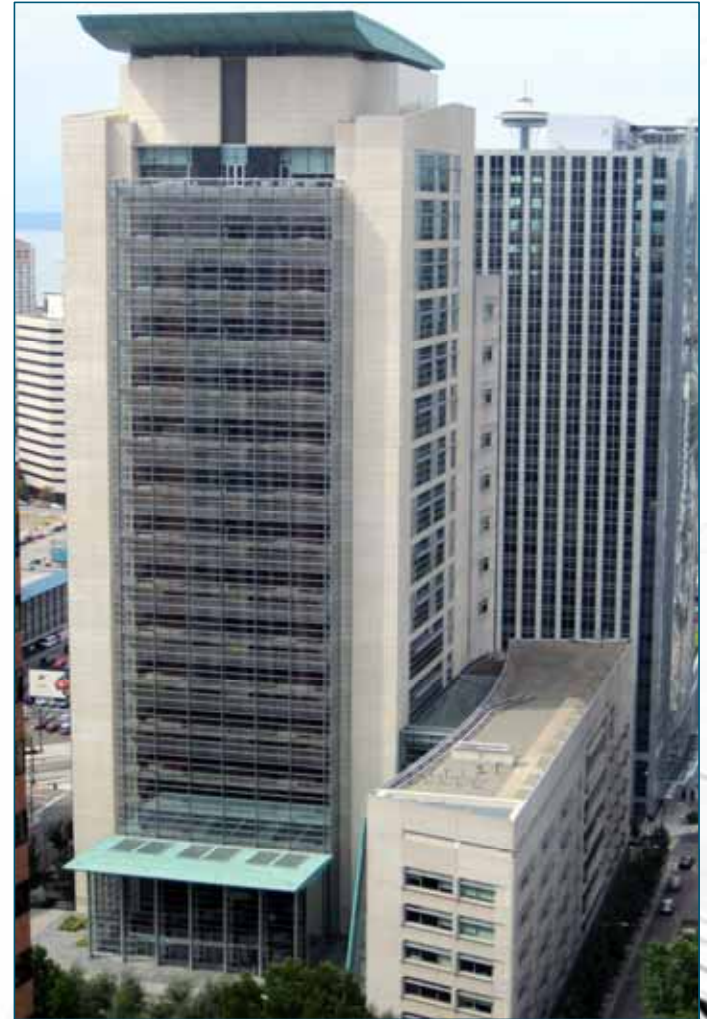
Sealant Performance Construction Tolerances (Disappearing Joint - Construction Defect)

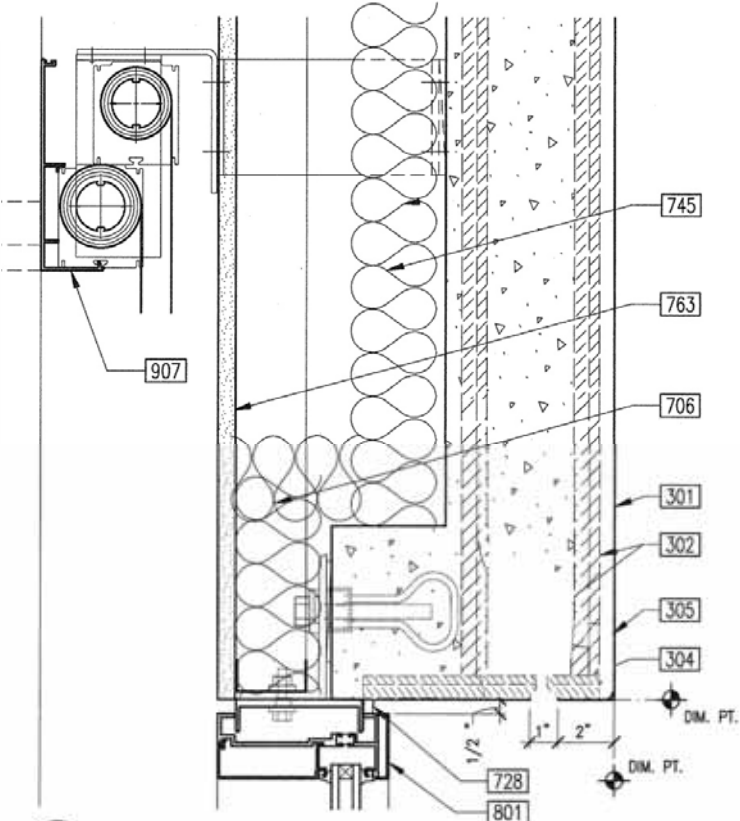
16 WINDOW HEAD AT PRECAST
SCALE: 3" = 1'-0"
...\\07 2d drawings\08 ext\dell\precast\8B2004 WINDOW 4.dgn

Rain Screen Sealant System

(Precast Panels)

Precast Sealant Must Connect With Window Sealant

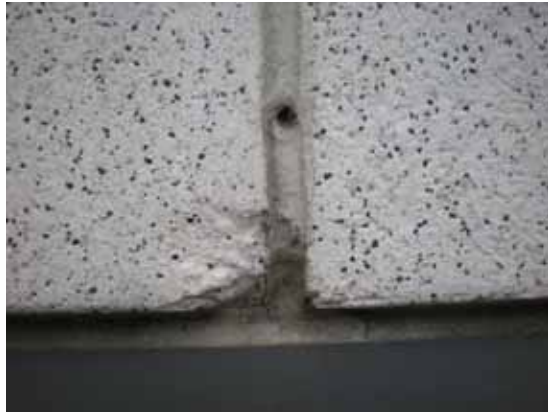
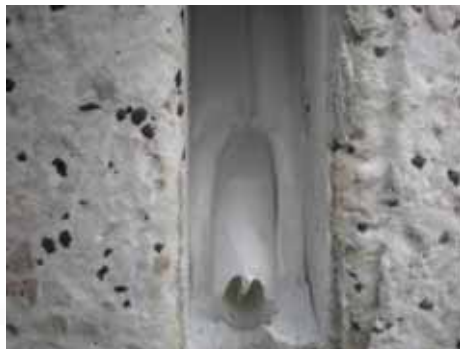
*** Construction Defects ***

(Plugged Weeps in 2-Stage Sealant Installation)

Placing silicone tape inside the joint first prevents the weep tube from blockage.

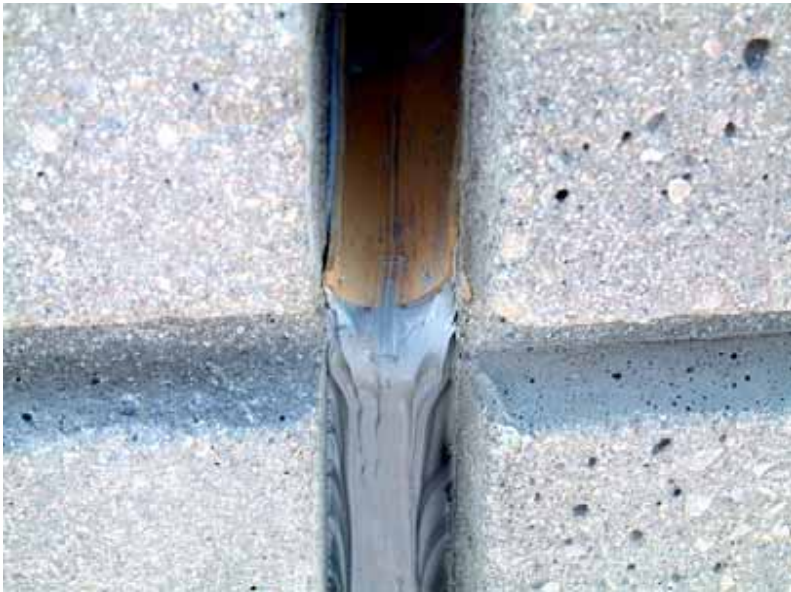
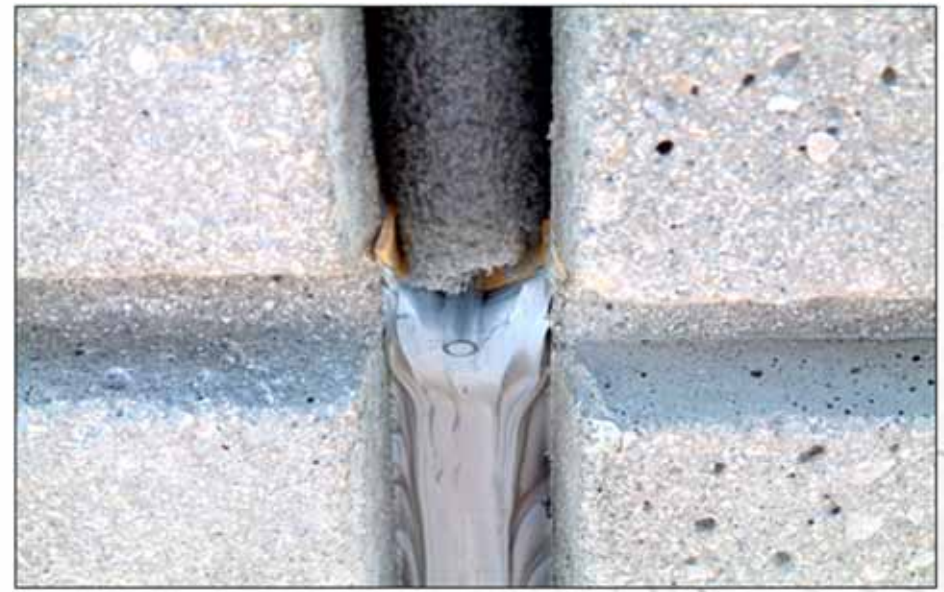
Sealant Performance

***** Best Practice *****
(Rain Screen Trough with Weep)

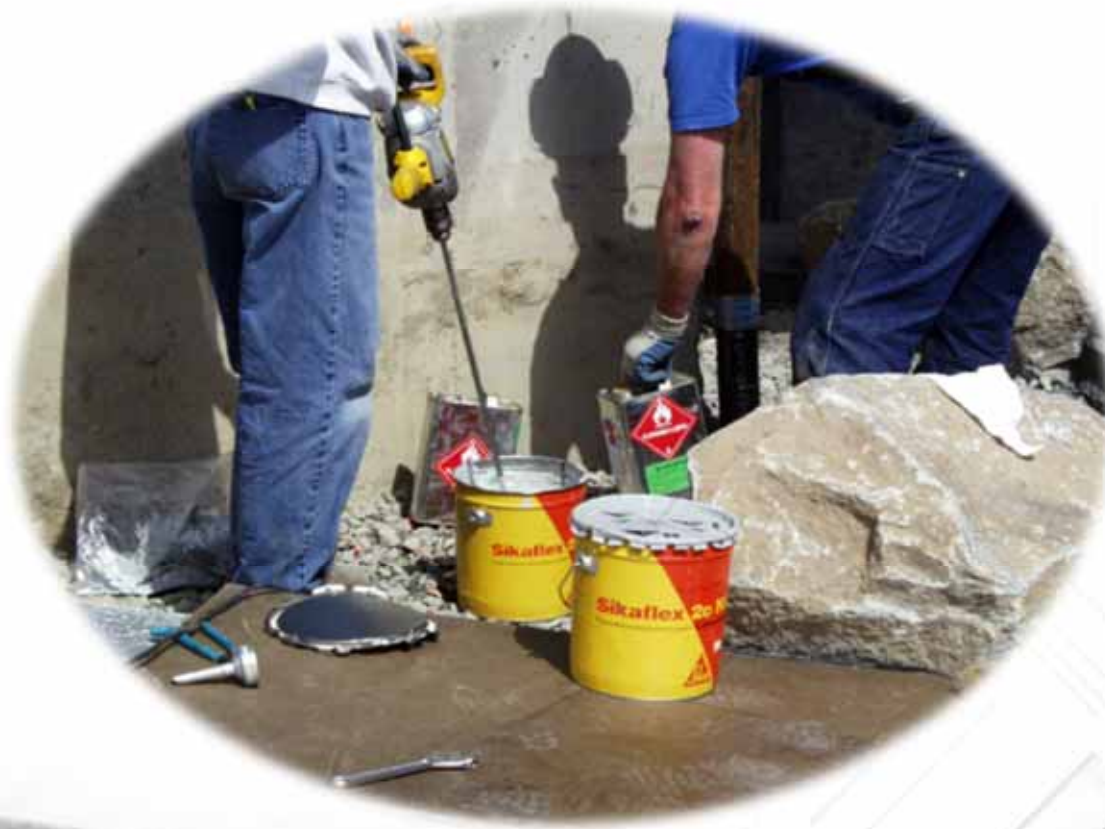
Applicator is adding solvent
to thin down the urethane.
Never recommended.

Sealant Performance

***** Construction Defects *****
(Misuse of Multicomponent Sealant)

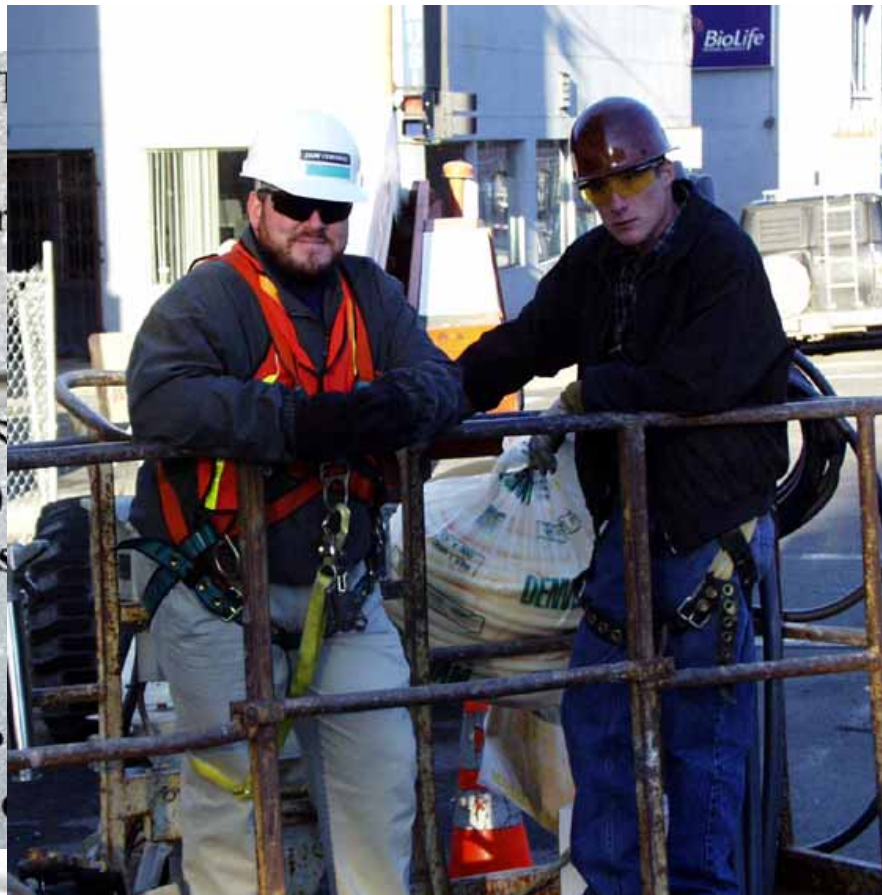
On Site Adhesion Testing (Mock Ups)
